Hilfield Solar Farm and Battery Storage

Ground Investigation Assessment

**GROUND INVESTIGATION ASSESSMENT
LAND AT SLADES FARM BUTTERFLY LANE
ALDENHAM ELSTREE WD6 3AD
FOR
AARDVARK EM LTD**

JUNE 2020

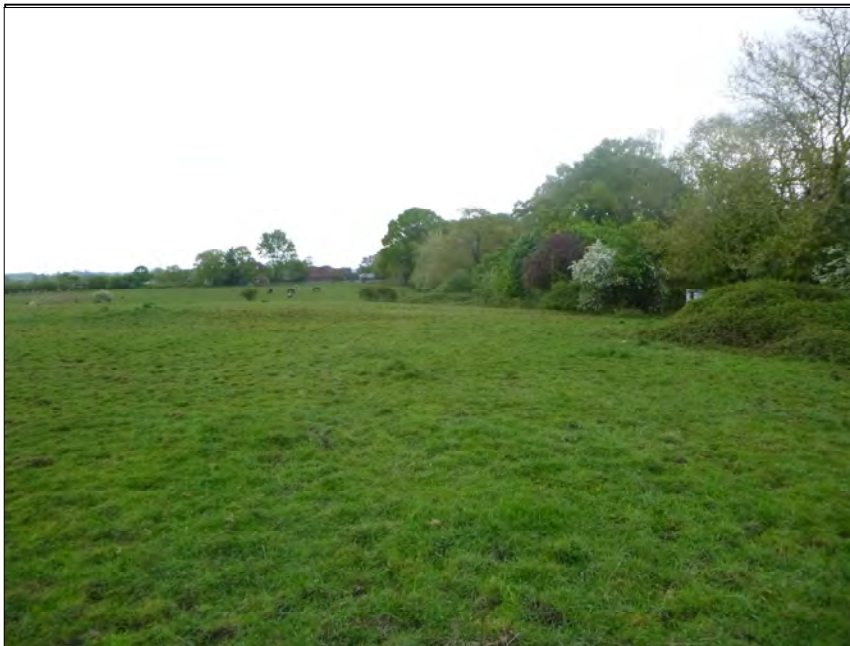
View looking north east along north western site boundary (above) and east north east towards Slades Farm from southern boundary of site parallel with Butterfly Lane (below)

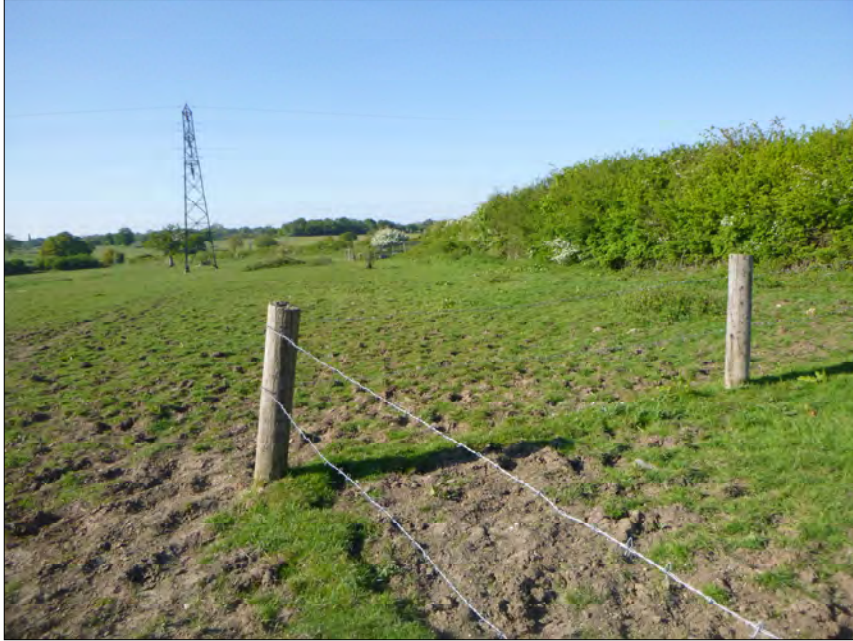
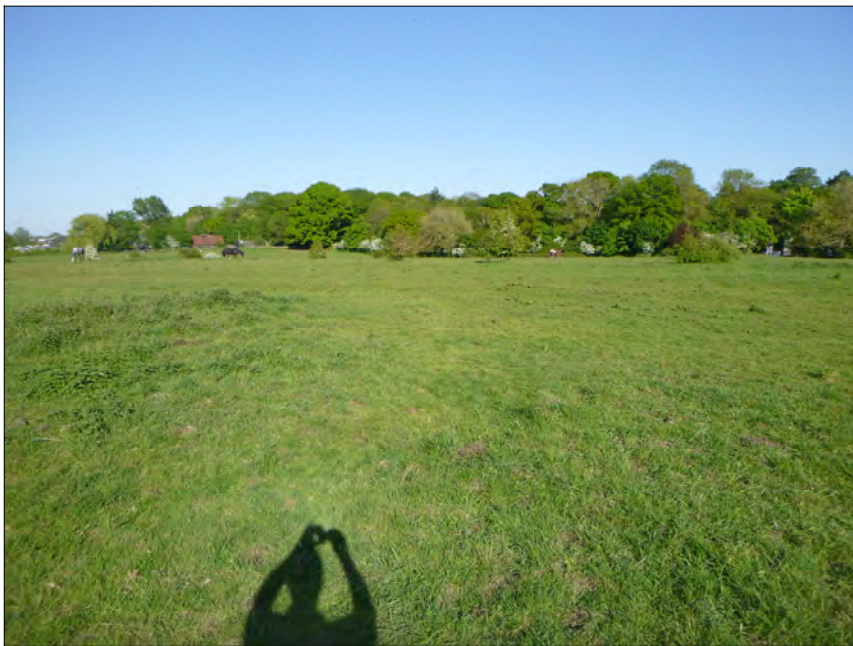
View looking north west along north eastern site boundary near Slades Farm (above) and east towards Slades Farm from western site boundary (below)
