Hilfield Solar Farm and Battery Storage

Ground Investigation Assessment

**GROUND INVESTIGATION ASSESSMENT
LAND AT SLADES FARM BUTTERFLY LANE
ALDENHAM ELSTREE WD6 3AD
FOR
AARDVARK EM LTD**

JUNE 2020

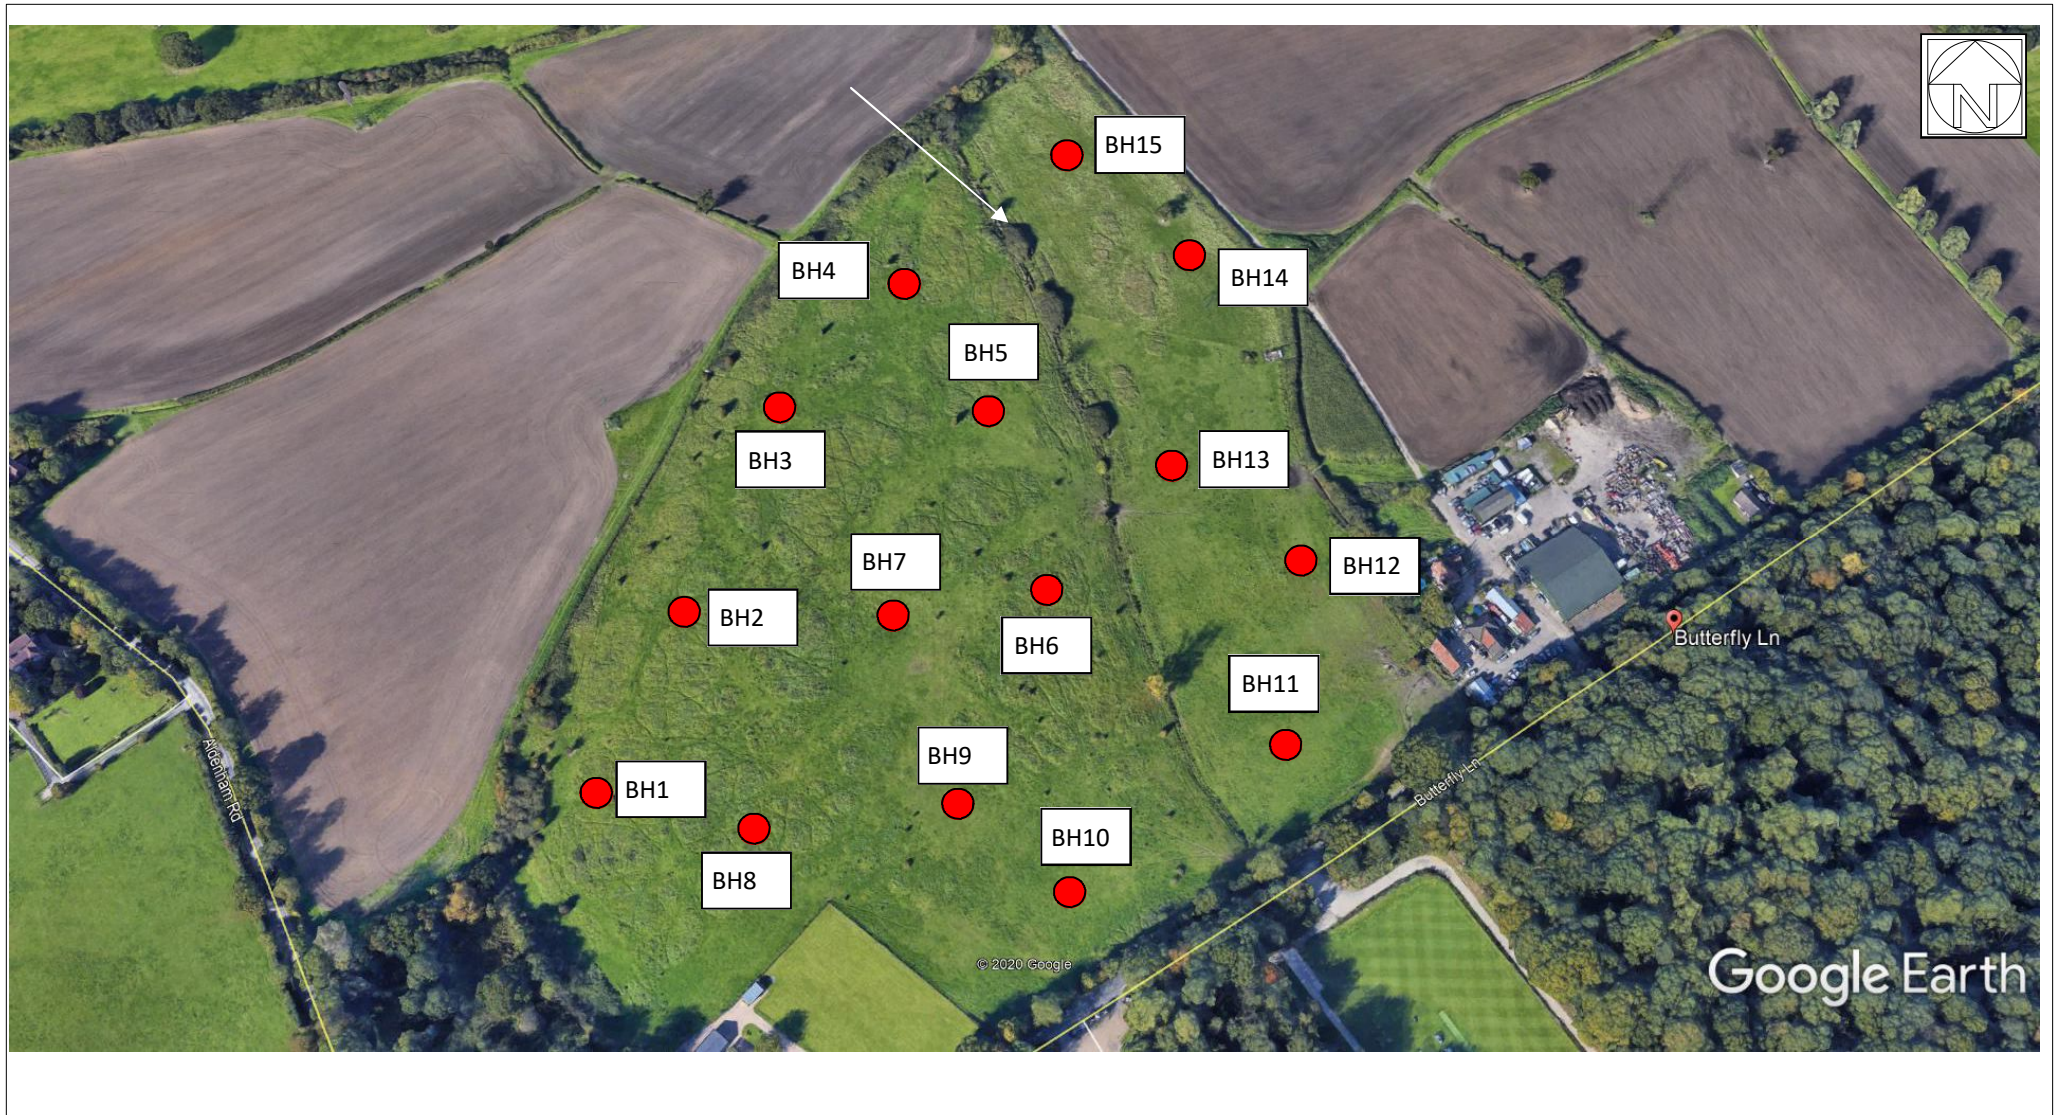
Figure 2 Plan Showing Approximate Positions of Boreholes

A Drawing showing the site layout and approximate borehole positions (Figure 2), is also provided in Appendix 1 of the current Report.

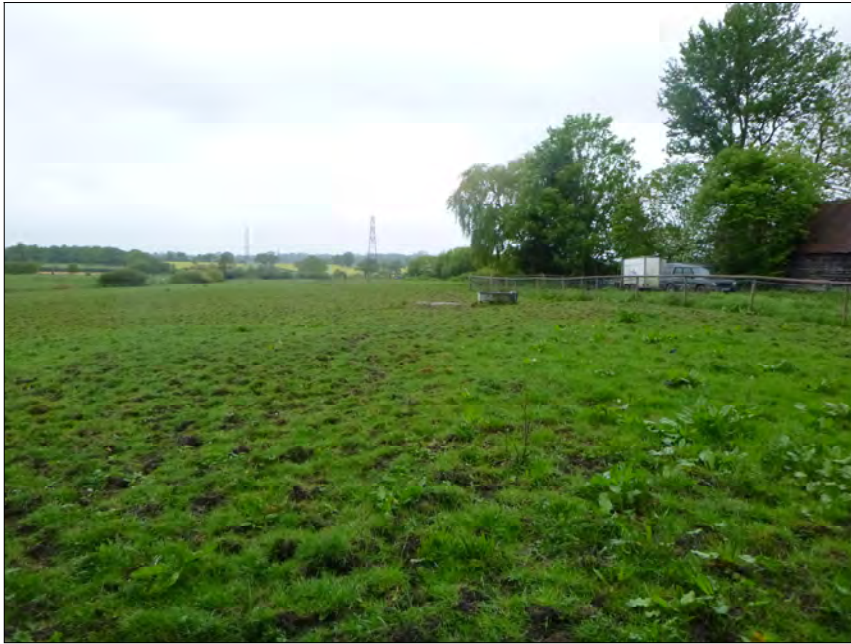
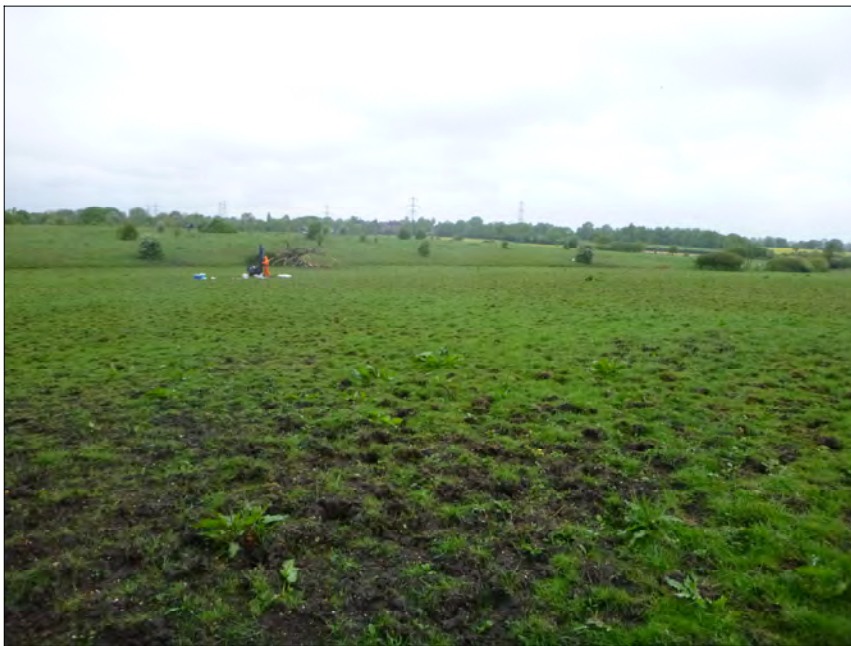
**View across eastern side of study site looking north
north west (above) and
looking north west (below) from near Slades Farm on
eastern corner of site**

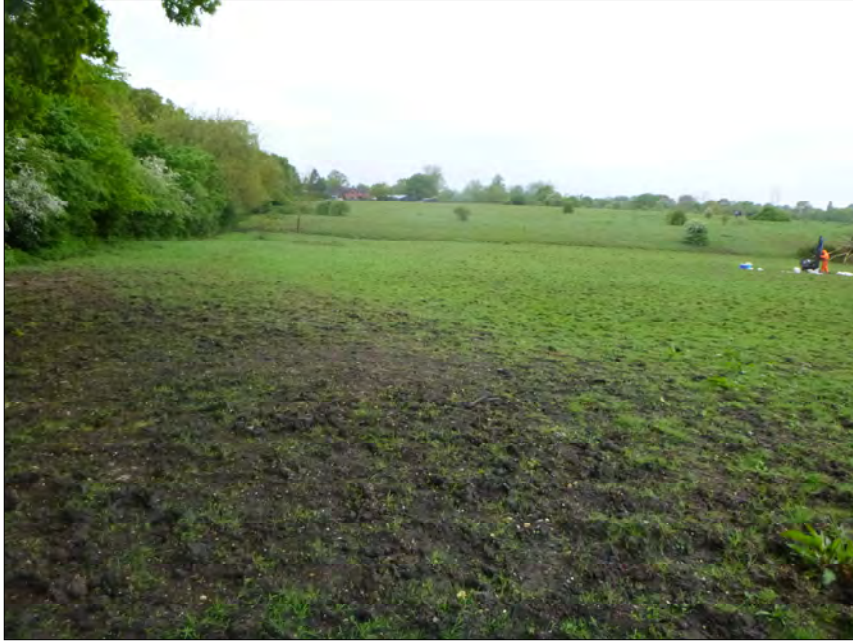
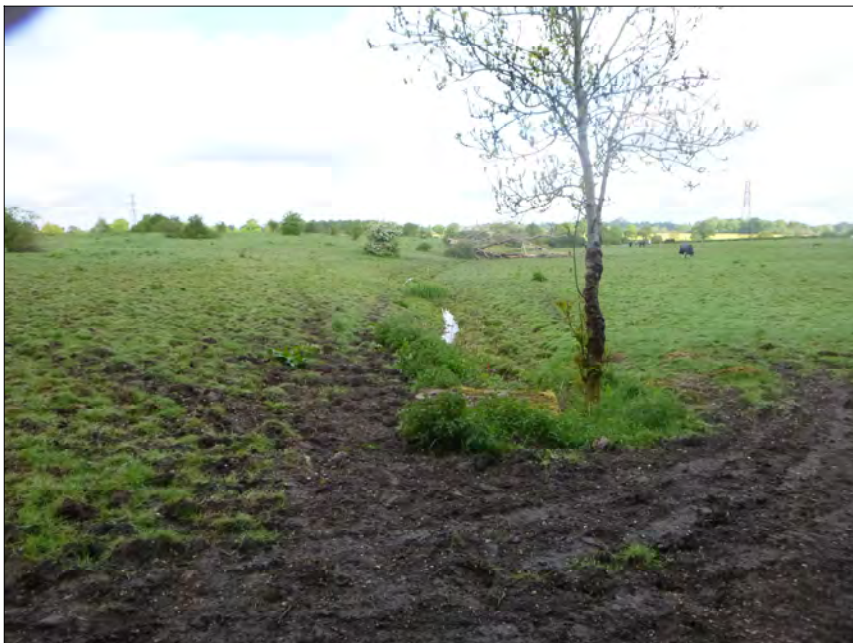
View across study site parallel with Butterfly Lane looking south west from near Slades Farm (above) and (below) looking north north west along bisecting stream near boundary with Butterfly Lane

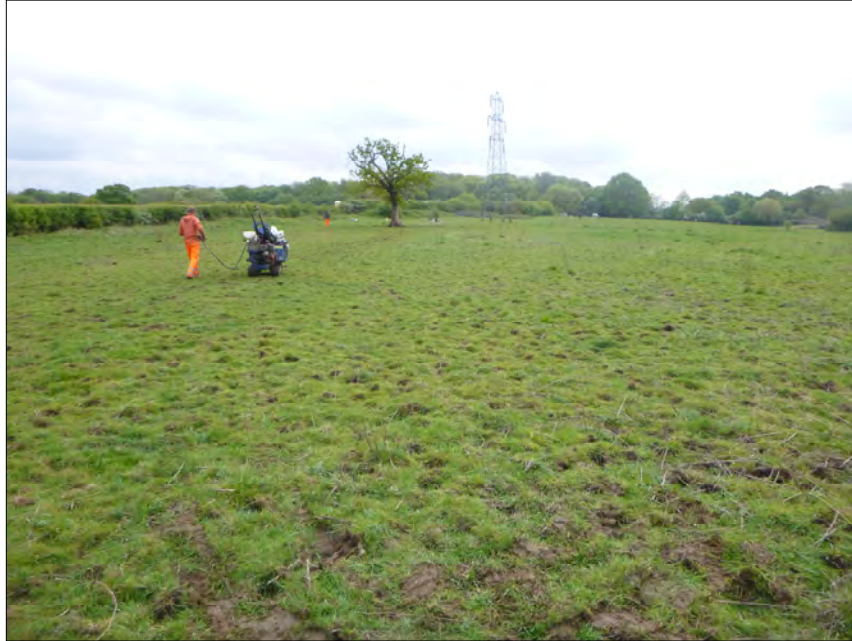
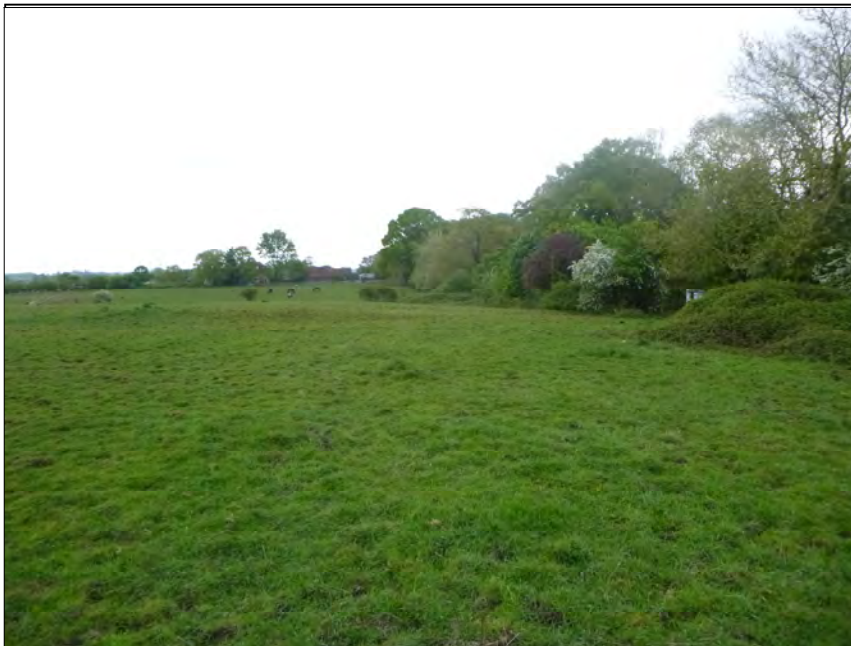
View looking north east along north western site boundary (above) and east north east towards Slades Farm from southern boundary of site parallel with Butterfly Lane (below)

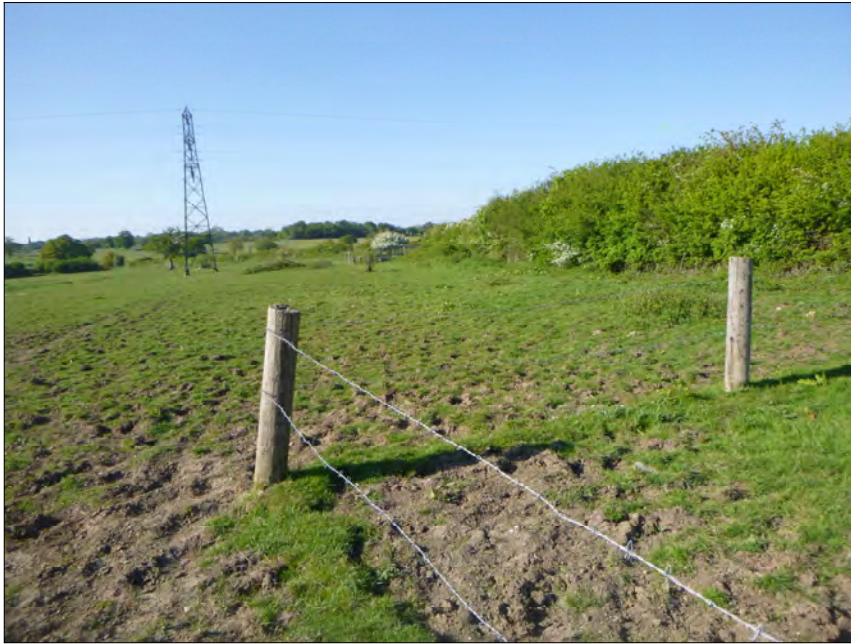
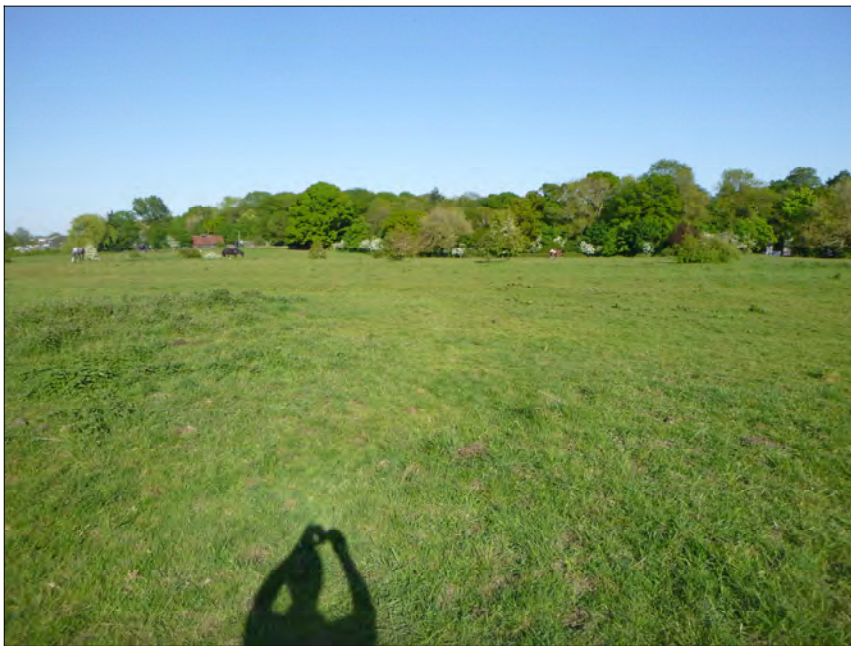
View looking north west along north eastern site boundary near Slades Farm (above) and east towards Slades Farm from western site boundary (below)

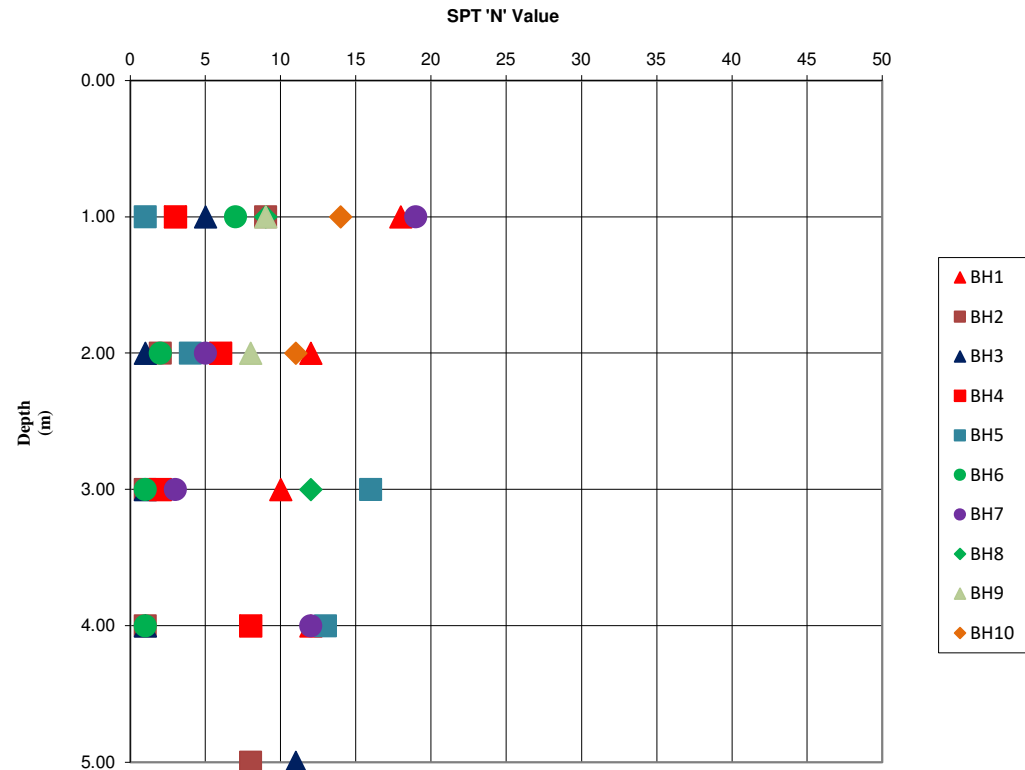
BH1-BH10 (over Landfill)

The SPT 'N' values are plotted against depth on the two appended sheets provided in Appendix 4 of the current Report, one for boreholes BH1-BH10 located on the western section of the site

BH1		BH2		BH3	
Depth (m)	SPT 'N' value	Depth (m)	SPT 'N' value	Depth (m)	SPT 'N' value
1.00	18	1.00	9	1.00	5
2.00	12	2.00	2	2.00	1
3.00	10	3.00	1	3.00	1
4.00	12	4.00	1	4.00	1
		5.00	8	5.00	11
BH4		BH5		BH6	
Depth (m)	SPT 'N' value	Depth (m)	SPT 'N' value	Depth (m)	SPT 'N' value
1.00	3	1.00	1	1.00	7
2.00	6	2.00	4	2.00	2
3.00	2	3.00	16	3.00	1
4.00	8	4.00	13	4.00	1
BH7		BH8		BH9	
Depth (m)	SPT 'N' value	Depth (m)	SPT 'N' value	Depth (m)	SPT 'N' value
1.00	19	1.00	9	1.00	9
2.00	5	3.00	12	2.00	8
3.00	3				
4.00	12				
BH10					
Depth (m)	SPT 'N' value				
1.00	14				
2.00	11
